Manhole Inspection Summary

Manhole # S37CC1024MH

Insp Date: **12/8/06 8:31 AM**

Location Address: **407 SUFFOLK RD**

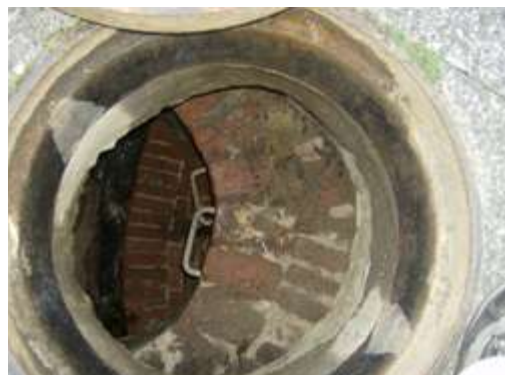
Top View

Adjustment infiltration. Bench debris.

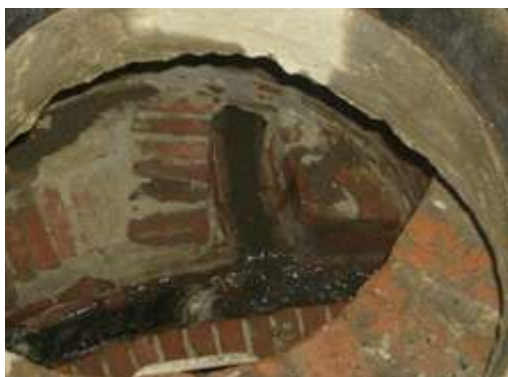
Defect

Adjustment infiltration.

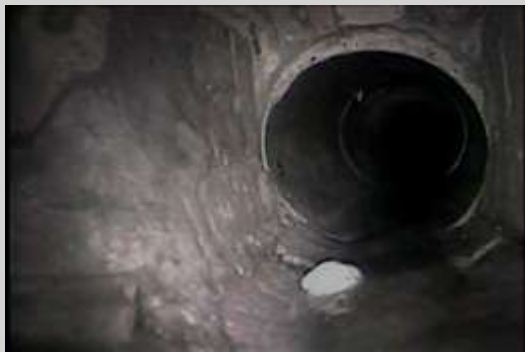
10 in. Circular Gravity Sewer Pipe Out @ 12 O'Clock

Deposits: ☒ None ☐ Mud ☐ Sludge ☐ Debris ☐ Grease

Infiltration: **None** Pipe Seal Cond: **Unknown**

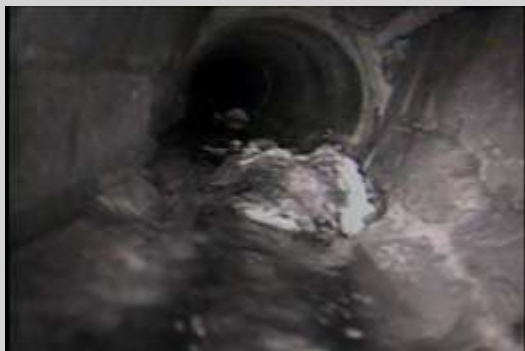
8 in. Circular Gravity Sewer Pipe In @ 5 O'Clock

Deposits: ☐ None ☒ **Mud** ☐ Sludge ☒ **Debris** ☐ Grease

Silt Depth: **0** (in.) Deposits Extent: **Light**

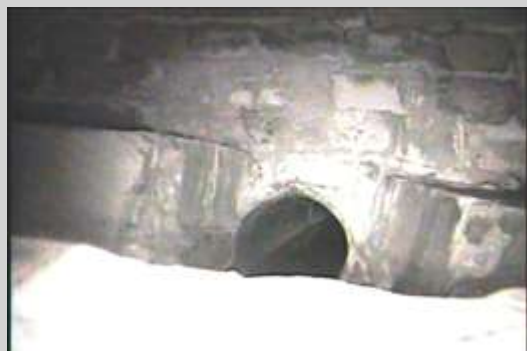
8 in. Circular Gravity Sewer

Barrel infiltration.
